# REPAIRING A 3-YEAR OLD POOL

SOUTH REGIONAL AQUATIC WELLNESS CENTER  
FORT WASHINGTON, MD

## Replacing Rusted Steel Rebar With Fiberglass Rebar For Greater Durability

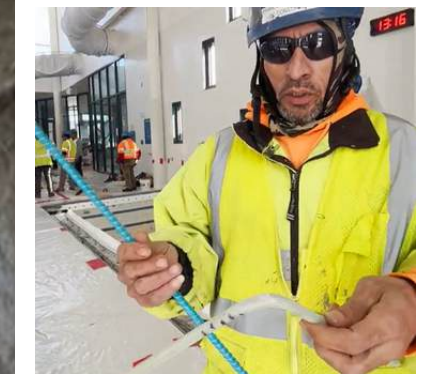
M-NCPPC'S South Regional Aquatic Wellness Center was constructed in 2021 and immediately started having issues with corrosion and discolored water from rusting steel reinforcement in the wall and coping. In 2024, Tobar Construction was contracted to remove and replace the corroded steel and problematic concrete.

**CORRODED REBAR**

Corrosion-free fiberglass rebar from MST Bar was chosen to ensure that this issue did not appear ever again—fiberglass has a 100+ year lifetime. Installing fiberglass rebar was the same as steel, but quicker. Fiberglass is faster to cut, lighter, and pliable, meaning the crews were quickly able to complete the curvy coping shapes. Placement went so quickly that it was a full day ahead of schedule. The corrosion-free material also meant the repair could be shallower (0.75" vs 1.50"), preserving more of the existing concrete.

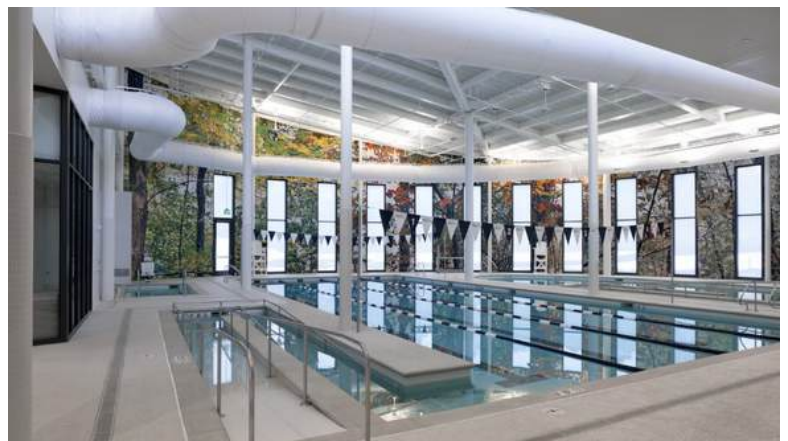
Local fiberglass expert Ernest Maier was able to quickly supply Tobar all the needed reinforcement from inventory at prices lower than black steel. Tobar is excited to fix more corroding concrete using corrosion-free and easy-to-install fiberglass from MST Bar and Ernest Maier.
